# Technical *Info*

## Installation tip for timing belt kit CT 957 K1 – WP4: e.g. Audi / VW / Skoda / Seat 1.4 /1.6 16V

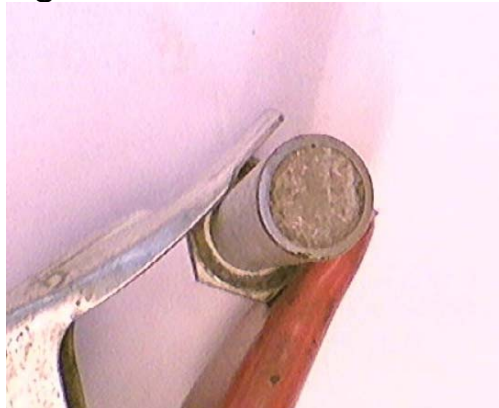
Fig. 1

The tensioning pulley fastening screw has snapped off.

Because too low a tension was set and/or the contact surface with the engine was not correct, the pulley loosened slightly during operation, resulting in the screw being subjected to flexing stresses and then shearing.
